# Solder Alloy choice for through hole ceramic discoidal & planar array capacitors

Application Note  
Reference No. AN0011  
Solder Alloy choice for  
through hole ceramic  
discoidal & planar array  
capacitors Issue 3

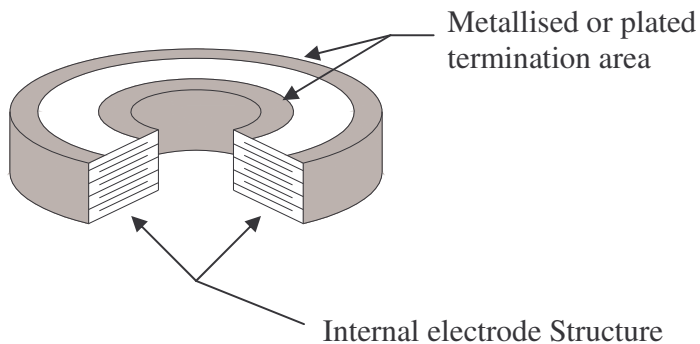
FIG 1  
TYPICAL DISCOIDAL  
CONSTRUCTION

Through hole ceramic capacitors are based on the technology of multi layer chip capacitors (MLCC's) with modified internal architecture. The manufacture is similar to MLCC's in that layers of ceramic dielectric material interlaced with precious metal electrodes are built up to form the structure, but holes are then drilled in the ceramic to form contacts to the inner or hot electrodes. The outside is machined to shape and makes contact to the outer or cold electrodes. The capacitance is formed between the hole and the outside edge. In the case of planar arrays, capacitance is formed between each hole and the outside edge. Within limits, each hole can have different capacitance characteristics.

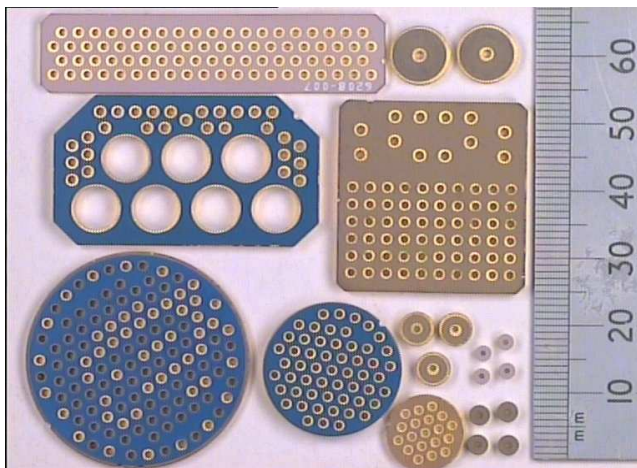
FIG 2  
EXAMPLES OF DISCOIDAL  
AND PLANAR ARRAY  
CAPACITORS

Single hole devices are usually referred to as discs (they are not necessarily circular) whilst multi hole devices are referred to as planar arrays.

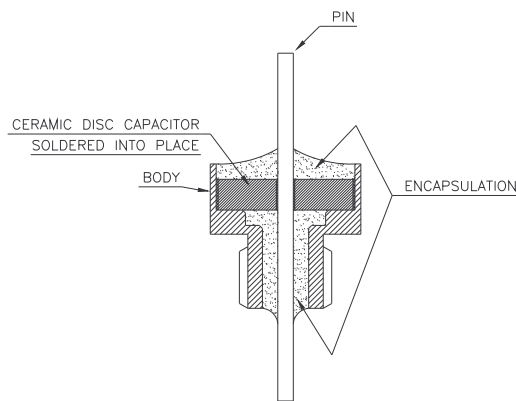
**FIG 3**  
TYPICAL EMI FILTER  
CONSTRUCTION

The finished capacitor device is used in the assembly of EMI filters and filter assemblies. Their special construction allows the devices to have superior high frequency performance to SM chip based filtering – important for applications such as military, aeronautical and medical. For the construction of an EMI filter, the discoidal or array is soldered into a carrying can, or body, with a pin soldered through the centre. The assembly can then be encapsulated to give improved mechanical and environmental protection. The signal to be filtered is passed through the pin and the outside of the body connected to earth.

The pin and body are usually manufactured from Cu or Cu based alloys, plated with Ag or Au.

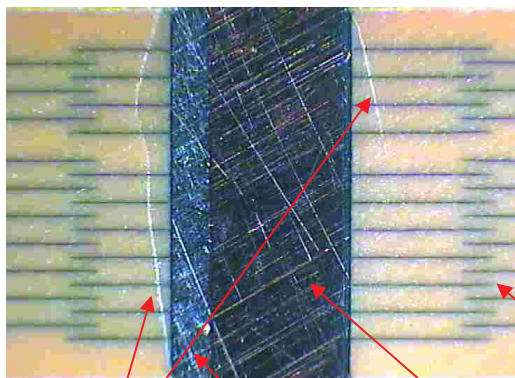
FIG 5

‘LONGBOW CRACK’

Capacitor soldered using 62Sn/36Pb/2Ag solder. Crack in dielectric material generated during cooling of solder joint after reflow.

It has been acknowledged for some years that soldering to the internal bore of the capacitor had the potential to induce cracks within the ceramic structure. The cracks generated by this process are known as ‘Longbow’ or ‘Comma’ cracks from their distinctive shape when viewed from a side cross section or top cross section respectively.

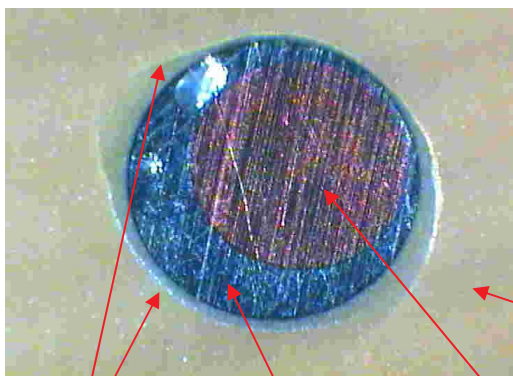
FIG 6

‘COMMA CRACK’

The same crack as in FIG 3 above, but sectioned through a plane 90° displaced.

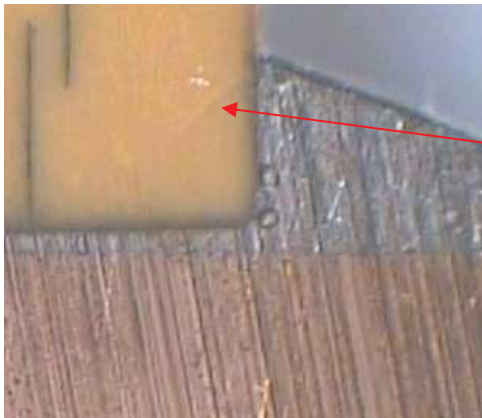
FIG 7  
'CORNER CRACK'

Crack generated by lifting of the pad due to the solder meniscus

A further form of crack commonly found in through hole ceramic capacitors is the corner crack. This occurs when the solder fillet on the surface pad shrinks causing the ceramic to crack and lift. It can be likened to the effect of pad lift on a circuit board.

Corner cracking is less critical than longbow / comma cracking and rarely threatens immediate outright dielectric failure, although the induced crack can propagate in operation causing failures. It can be eased by limiting the volume of solder in the meniscus or reducing the pad size. On very small size parts, it is common to remove the pad entirely.

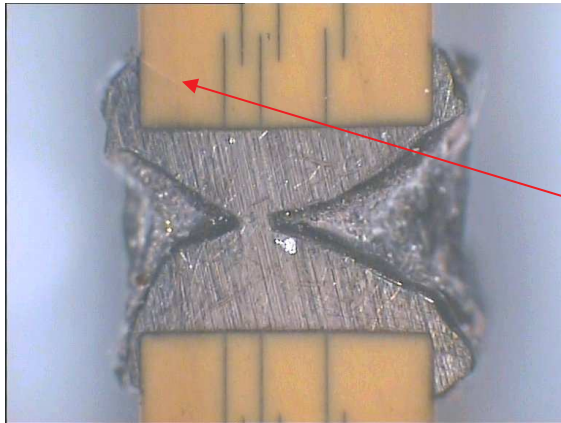
**FIG 8**

Example of solder joint from which pin has been removed before solder has solidified

Note small corner crack caused by solder meniscus

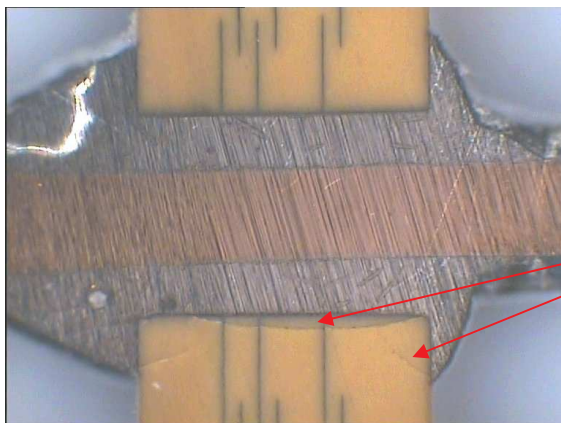
**FIG 9**

Example of solder joint with pin in place

Note longbow crack and corner cracks

This showed that the cracks only occur during the cooling portion of the soldering profile, and that pins must be present to generate the forces that form the longbow crack. This shows that the forces exerted on the ceramic are external to the capacitor.

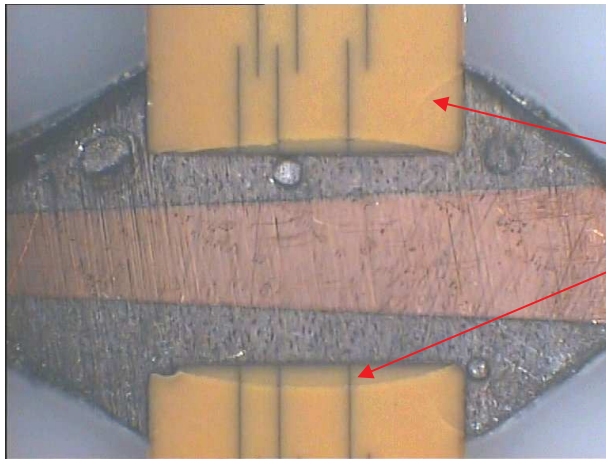
**FIG 10**

80% of the joints sectioned had longbow cracks adjacent to the solder joint. All the joints inspected had some cracking present in the ceramic, mostly corner cracks..

Example of force cooled  
62Sn/36Pb/2Ag solder joint  
showing longbow and corner  
cracks

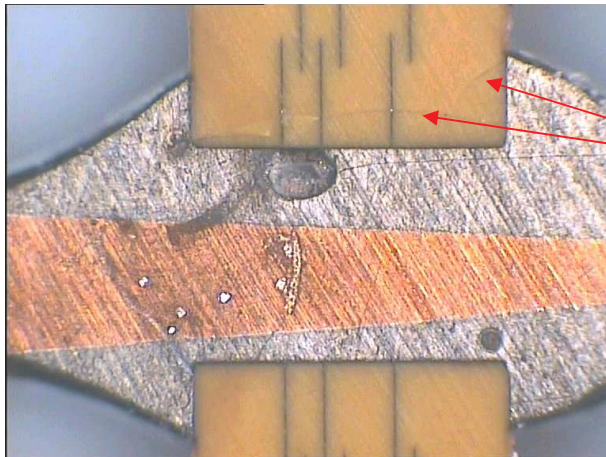
**FIG 11**

20% of the joints sectioned had longbow cracks adjacent to the solder joint. A total of 60% of joints had corner cracks associated with the solder meniscus.

Example of 62Sn/36Pb/2Ag  
solder joint showing  
longbow and corner cracks

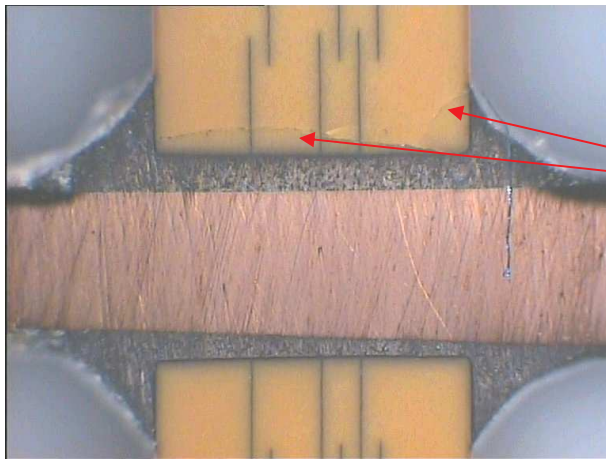
**FIG 12**

All of the joints sectioned had longbow cracks adjacent to the solder joint.  
All joints also has corner cracks.

Example of force cooled  
60Sn/40Pb solder joint  
showing longbow and corner  
cracks

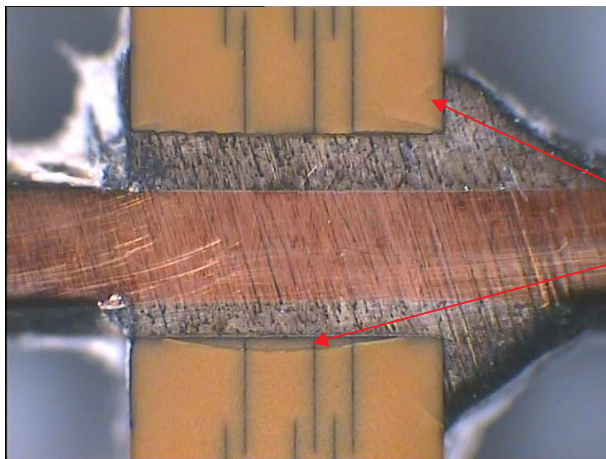
**FIG 13**

60% of the joints sectioned exhibited longbow cracks adjacent to the  
solder joint. A total of 80% of joints had corner cracks associated with the  
solder meniscus.

Example of 60Sn/40Pb solder  
joint showing longbow and corner  
cracks

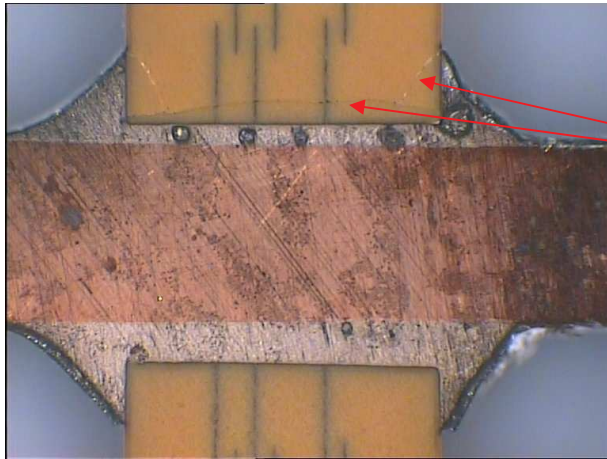
**FIG 14**

All of the joints sectioned had longbow cracks adjacent to the solder joint.  
All joints also has corner cracks.

Example of force cooled  
99.3Sn/0.7Cu solder joint  
showing longbow and corner  
cracks

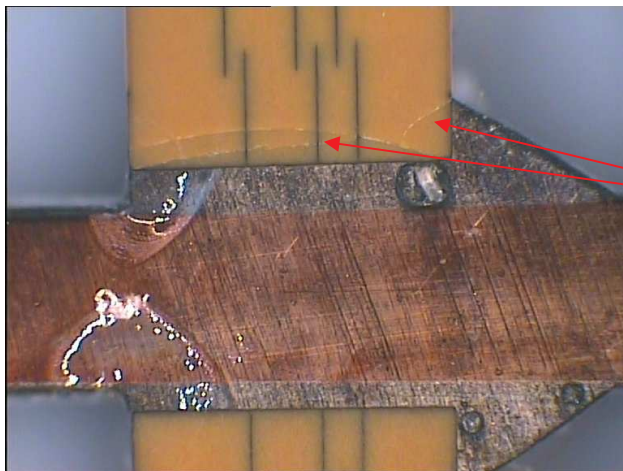
**FIG 15**

All of the joints sectioned had longbow cracks adjacent to the solder joint.  
All joints also has corner cracks.

Example of 99.3Sn/0.7Cu  
solder joint showing longbow  
and corner cracks

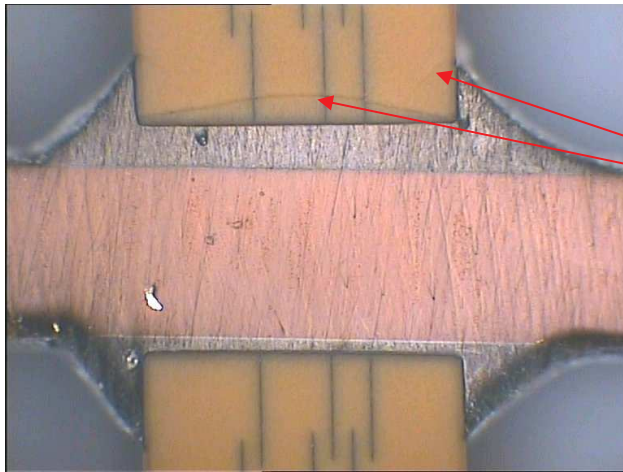
**FIG 16**

All of the joints sectioned had longbow cracks adjacent to the solder joint.  
All joints also has corner cracks.

Example of force cooled  
95.5Sn/3.8Ag/0.7Cu solder  
joint showing longbow and  
corner cracks

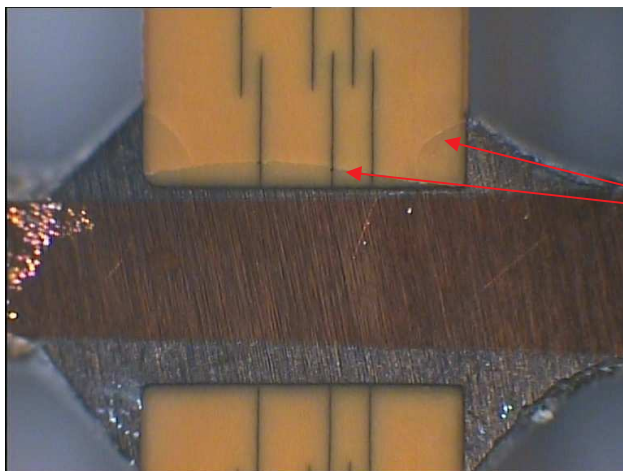
**FIG 17**

40% of the joints sectioned had longbow cracks adjacent to the solder  
joint. 80% of the joints in total had corner cracks, mainly corner cracks  
associated with solder pads.

Example of 95.5Sn/3.8Ag/0.7Cu  
solder joint showing longbow and  
corner cracks

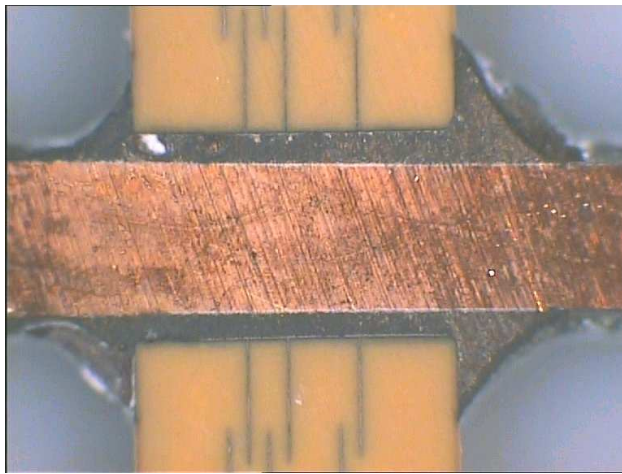
**FIG 18**

None of the joints sectioned exhibited any sign of induced cracks in the ceramic.

Example of force cooled  
50Pb/50In solder joint showing  
absence of any cracks

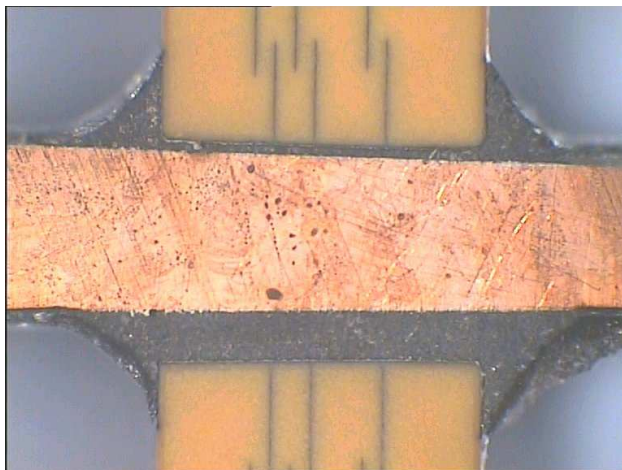
**FIG 19**

None of the joints sectioned exhibited any sign of induced cracks in the ceramic.

Example of 50Pb/50In solder joint  
showing absence of any cracks

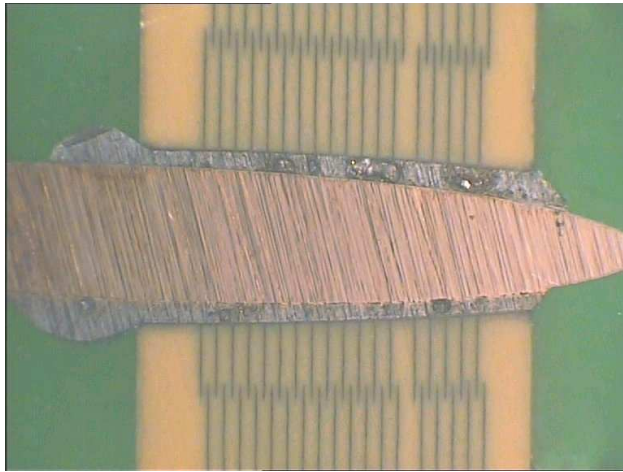
**FIG 20**

None of the joints sectioned exhibited any sign of induced cracks in the ceramic.

Example of force cooled  
95Pb/5In solder joint showing  
absence of any cracks

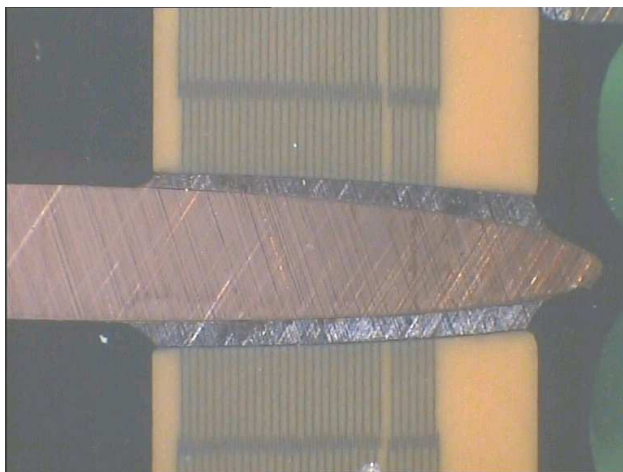
**FIG 21**

None of the joints sectioned exhibited any sign of induced cracks in the ceramic.

Example of 95Pb/5In solder joint  
showing absence of any cracks

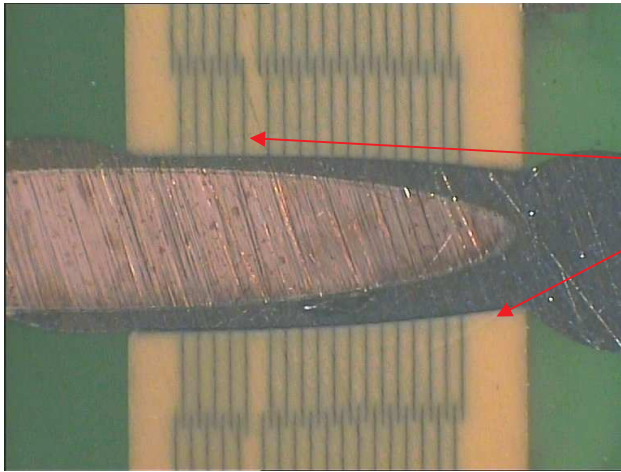
**FIG 22**

10% of the joints inspected showed very small longbow cracks adjacent to the solder joint. These were noticeably smaller than the cracks seen in other samples.

Example of 93.5Pb/5Sn/1.5Ag solder joint showing small longbow cracks.

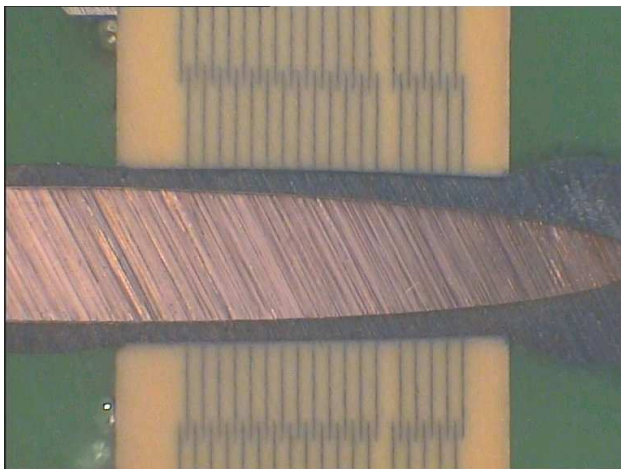
**FIG 23**

None of the joints sectioned exhibited any sign of induced cracks in the ceramic.

Example of 93.5Pb/5Sn/1.5Ag solder joint showing absence of any cracks

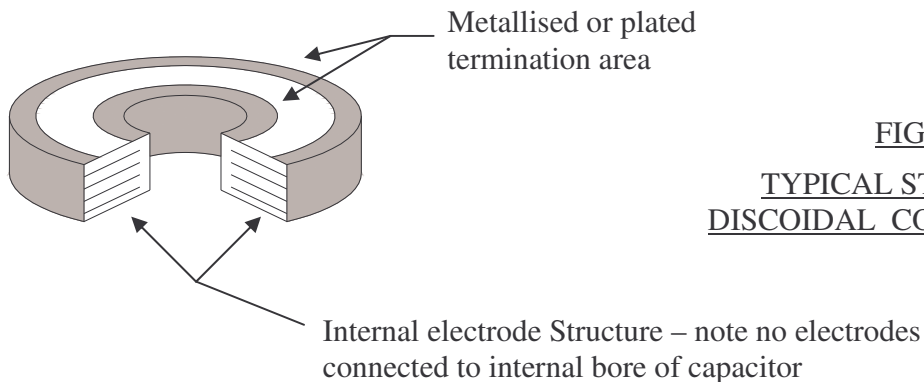
FIG 24  
TYPICAL STRAY CAP.  
DISCOIDAL CONSTRUCTION

The capacitance is created by the interaction of the internal bore termination and the outer earth electrodes.

The advantage of carrying out experiments with this type of construction is that any failure of the internal termination or ceramic cracking is demonstrated by a drop in the capacitance. This is because of the introduction of an alternative dielectric material – air – in the area of the failure.

Tests were carried out using capacitor arrays with the electrical design shown above and terminated with PdAg termination material. Prior to assembly, the capacitance of the holes with this design was recorded. The assembly was soldered using 95.5Sn/3.8Ag/0.7Cu solder and hot air reflow. After assembly, the capacitance was re-measured and the results tabulated below.

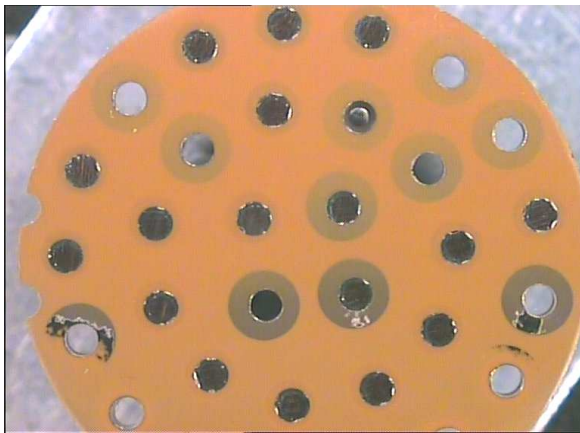
FIG 25

Surface Section of Array No. 2  
showing absence of damage to  
ceramic

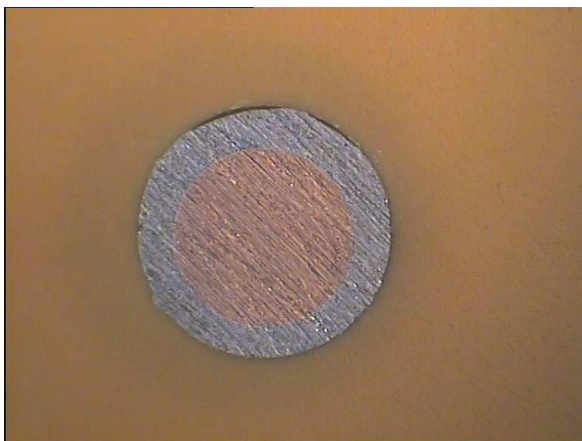
Close-up of Surface Section of Array  
No. 1 showing absence of damage to  
ceramic

One effect that can be seen from the surface sections above is that of solder / termination pull – away from the bore of the ceramic. This has the same effect as the cracks in gold plated parts, introducing a section of air dielectric within the capacitor build.

This effect can be seen in FIG 26 above. A further example is below :-

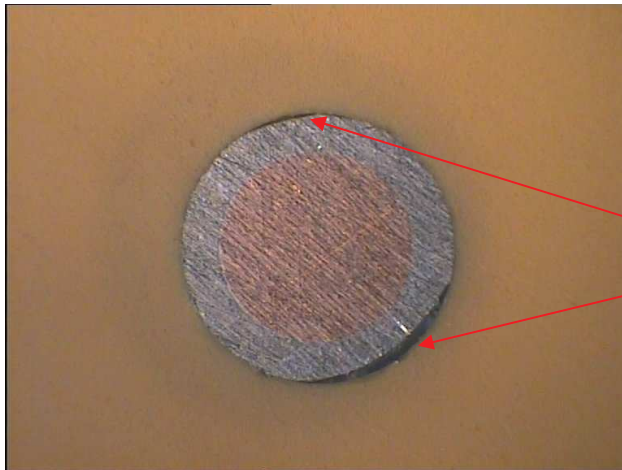
FIG 27

Second Close-up of Surface Section of Array No. 1 showing absence of damage to ceramic, but evidence of pull away of solder / termination from ceramic surface.

It is our conclusion that the unacceptable capacitance drop is caused by the failure of the termination / ceramic bond when exposed to excessive stress force as the solder / pin joint cools.

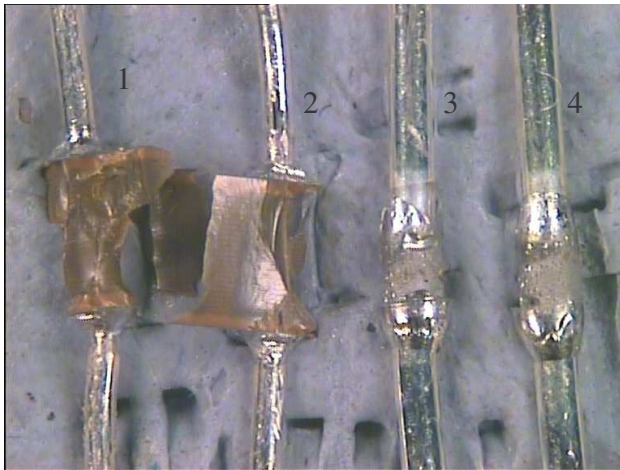
FIG 28

Silver plated copper pins soldered into planar array capacitors using 95.5Sn/3.8Ag/0.7Cu solder and removed by simply pulling out using a pair of pliers.

Pins 1 & 2 have been pulled from an array terminated with gold plate.

Pins 3 & 4 have been pulled from an array terminated with PdAg fritted termination.

As can be seen above, the gold plated termination has a far greater adhesion to the ceramic, demonstrated by the amount of ceramic material still attached to the pin. By comparison, the PdAg termination has been cleanly removed from the ceramic with no ceramic material removed. Pins 3 and 4 do show the PdAg termination still attached to the solder – identified by the dull grey areas on the solder.

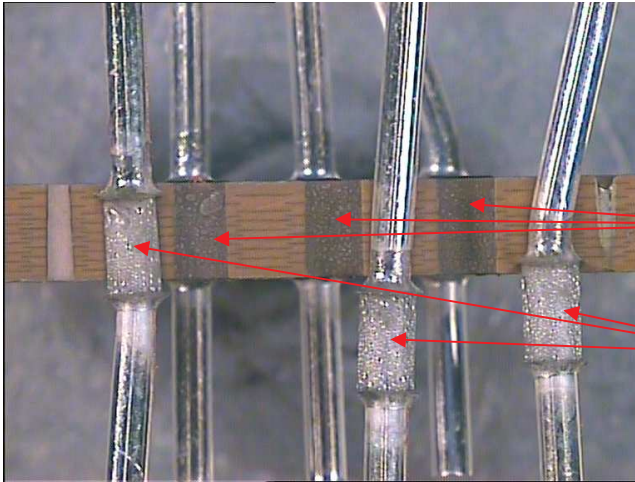
Fig 29

Example of PdAg terminated planar array capacitor soldered with 95.5Sn/3.8Ag/0.7Cu solder.

As the component is sectioned, the pins can be easily removed without damage to the ceramic.

Note the dark grey on the solder joint – this is the termination, which has been removed along with the pin & solder.

The ceramic exhibits no damage, and the pins are very easily removed – the termination has relatively little adhesion to the ceramic.

This is further shown in FIG 29, where the pins have been removed from a partially sectioned array soldered with PdAg termination.

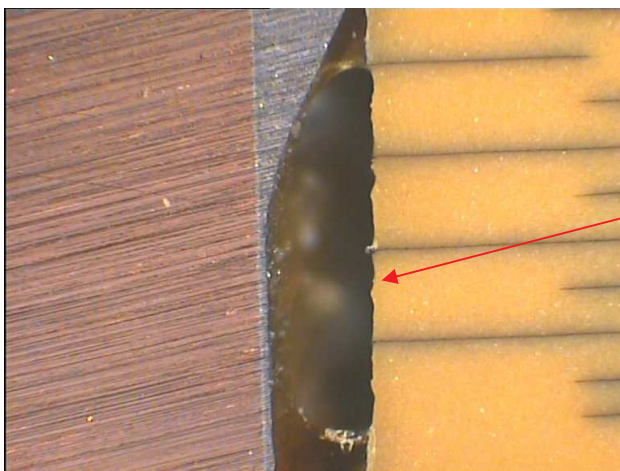
FIG 30

Termination leached away from this area.

These electrodes have lost contact and will result in a potential reduction in filtering performance.

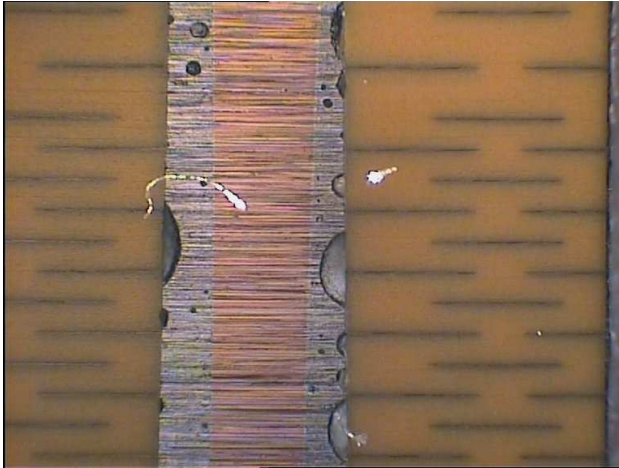
FIG 31

Further example of leaching  
and poor solder joint with  
PdAg termination.
